Debug Resurrection on nRF52 Series

BlackHat Europe 2020

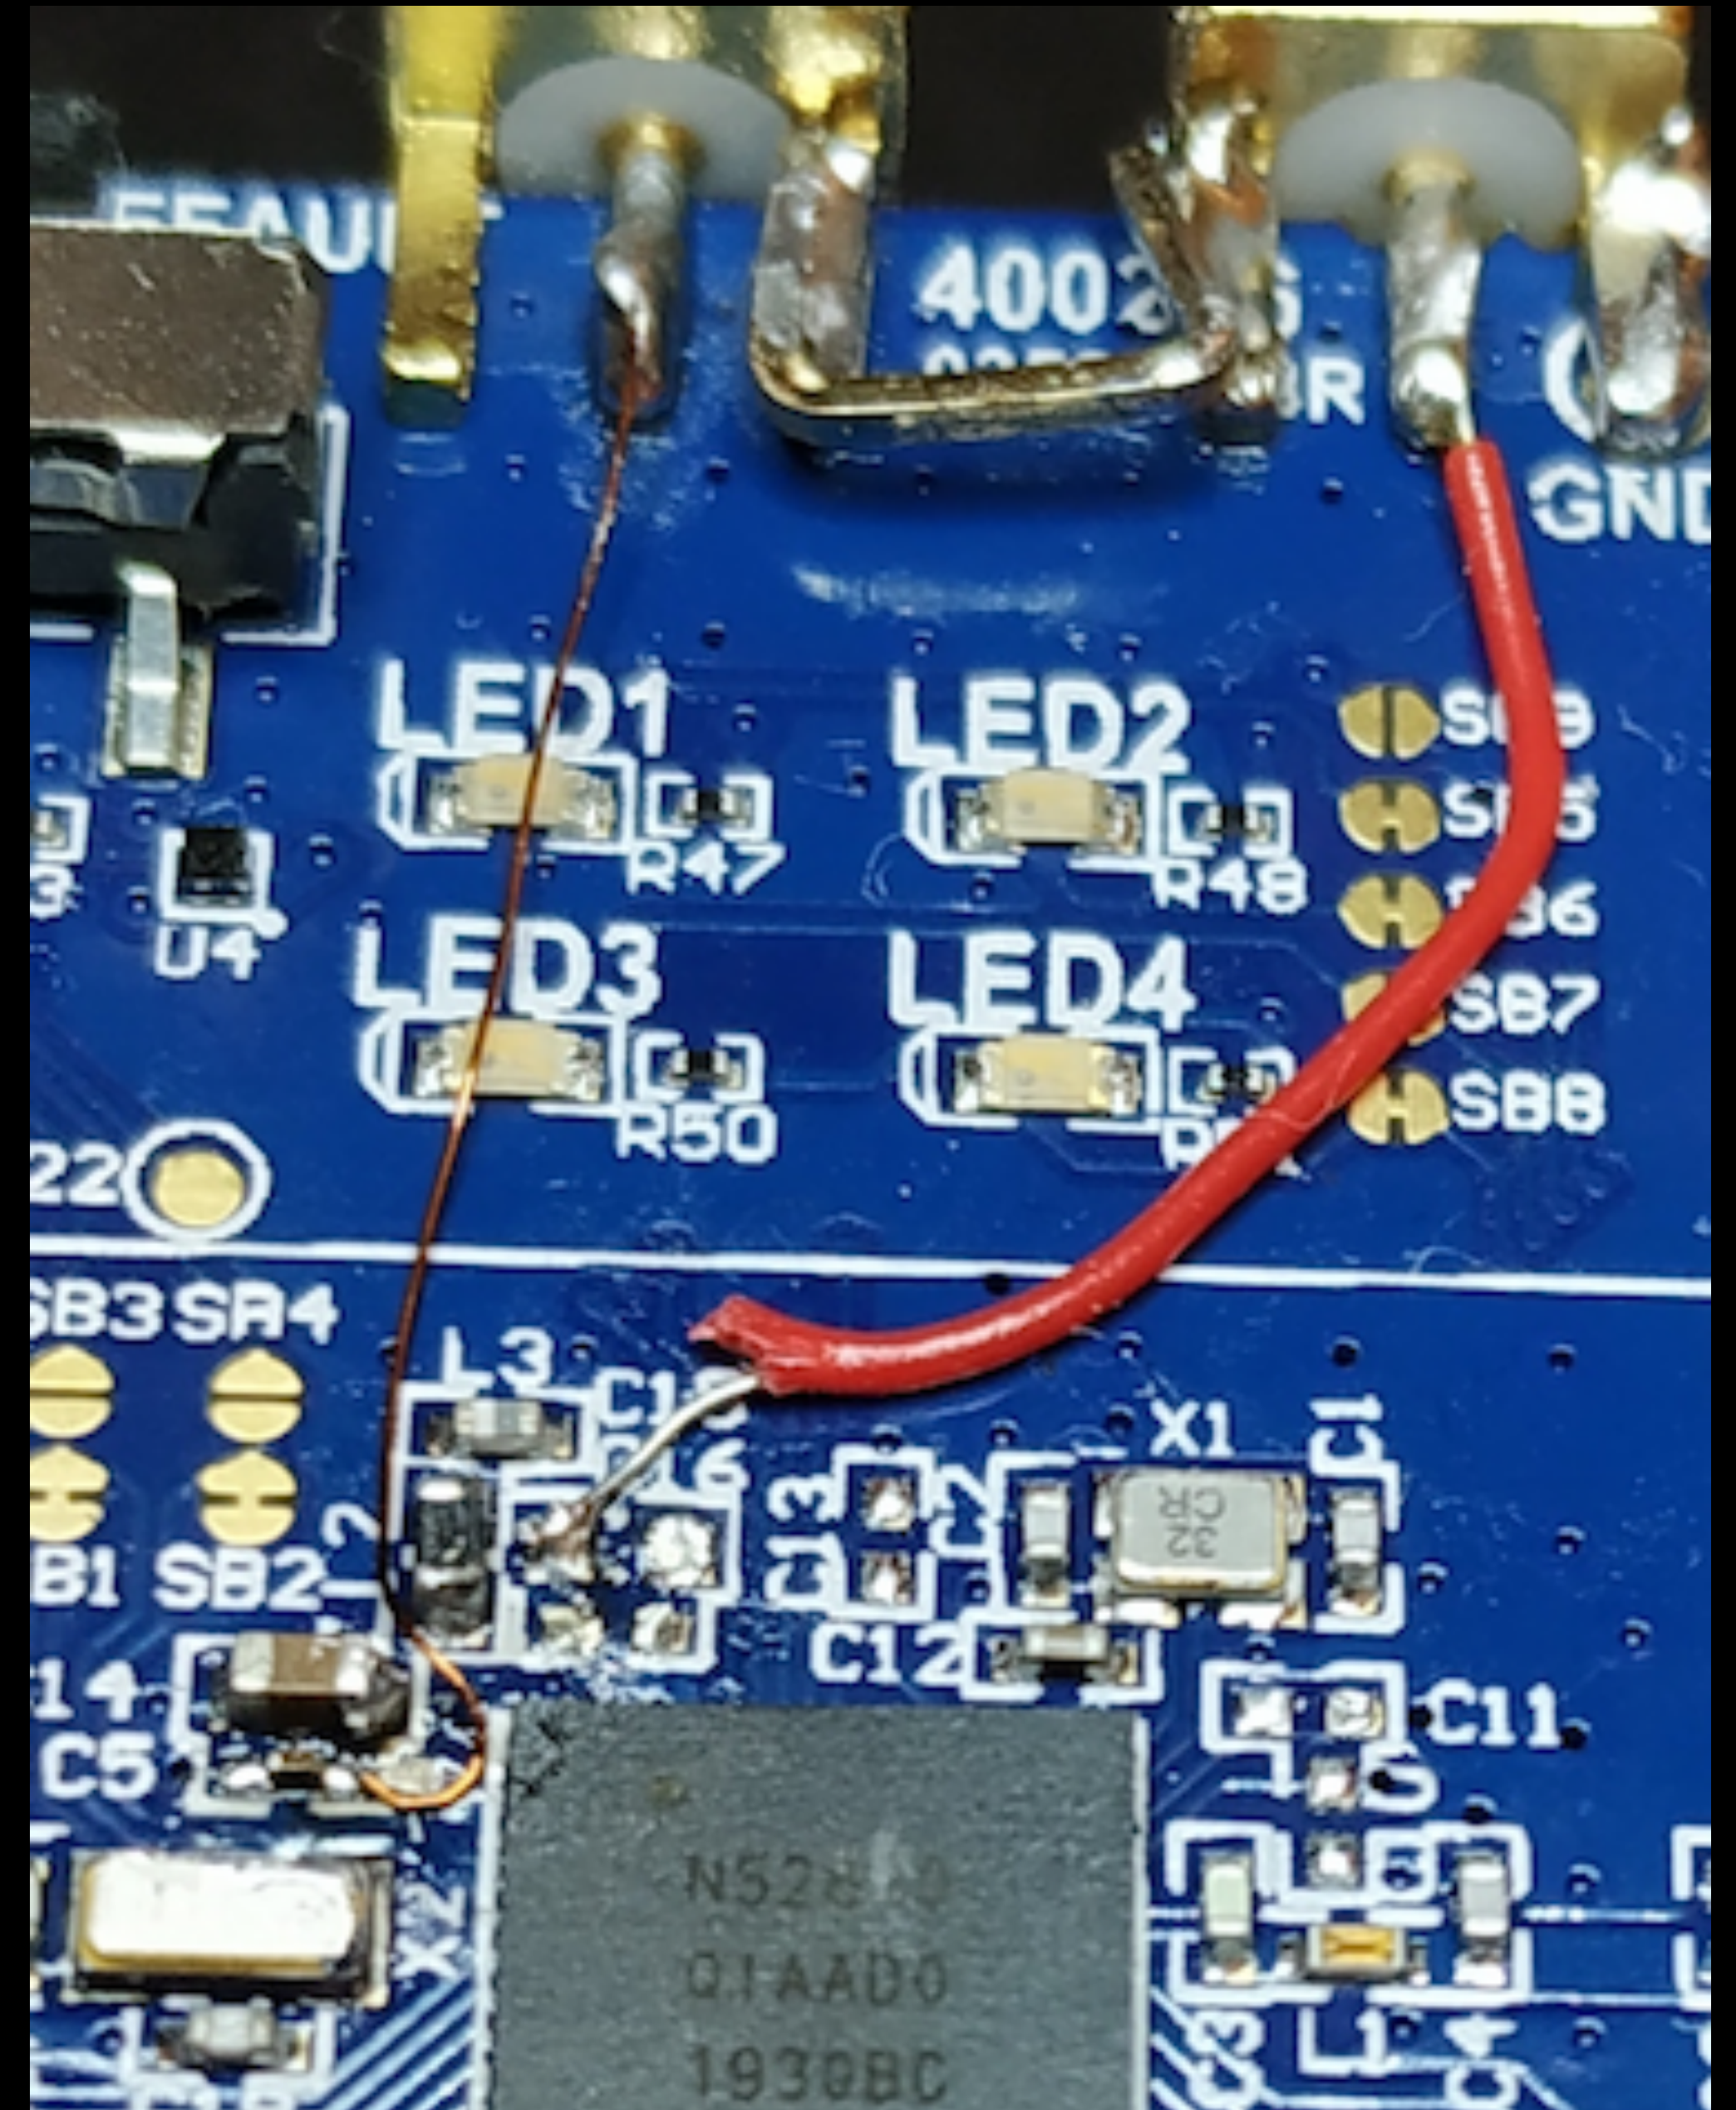
PCB Modification

- Magnet wire soldered to DEC1 then connected to a SMA connector
- Red wire soldered to DEC4 then connected to a second SMA connector
- GND point as a main Ground

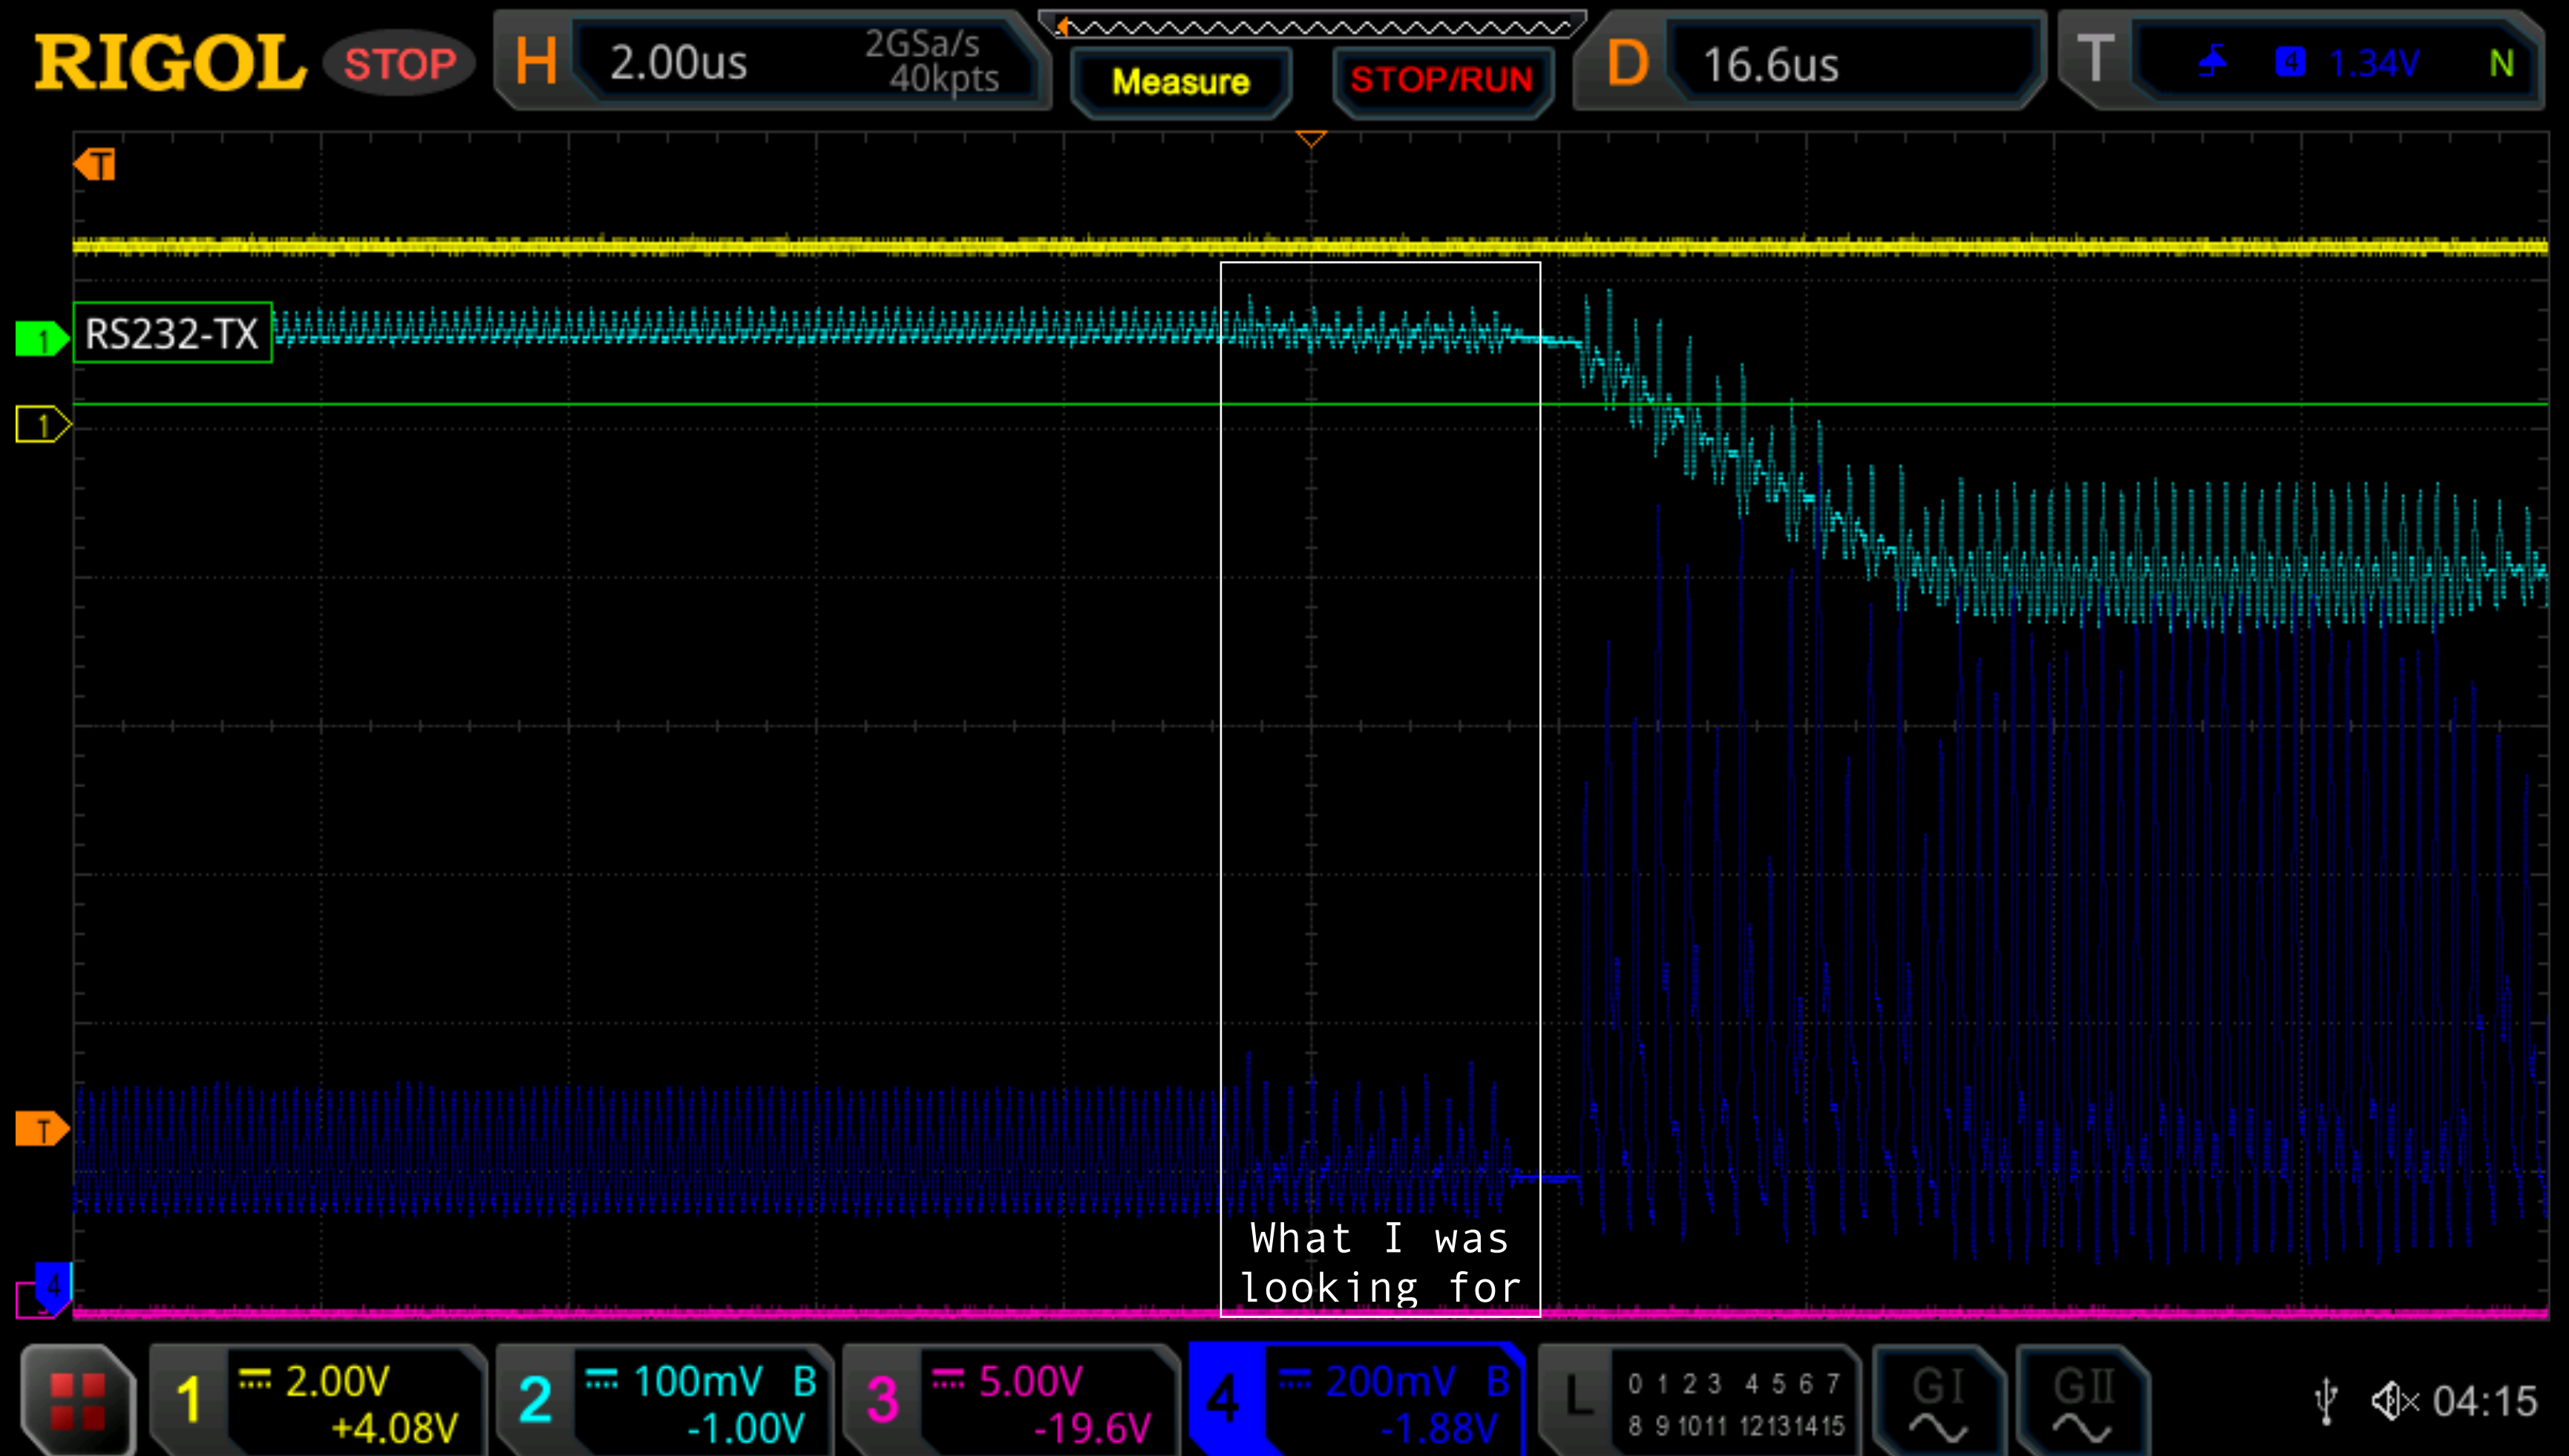
- Hardware Process identified
- Visible on DEC1 and DEC4
- Timing window of 2.5 us

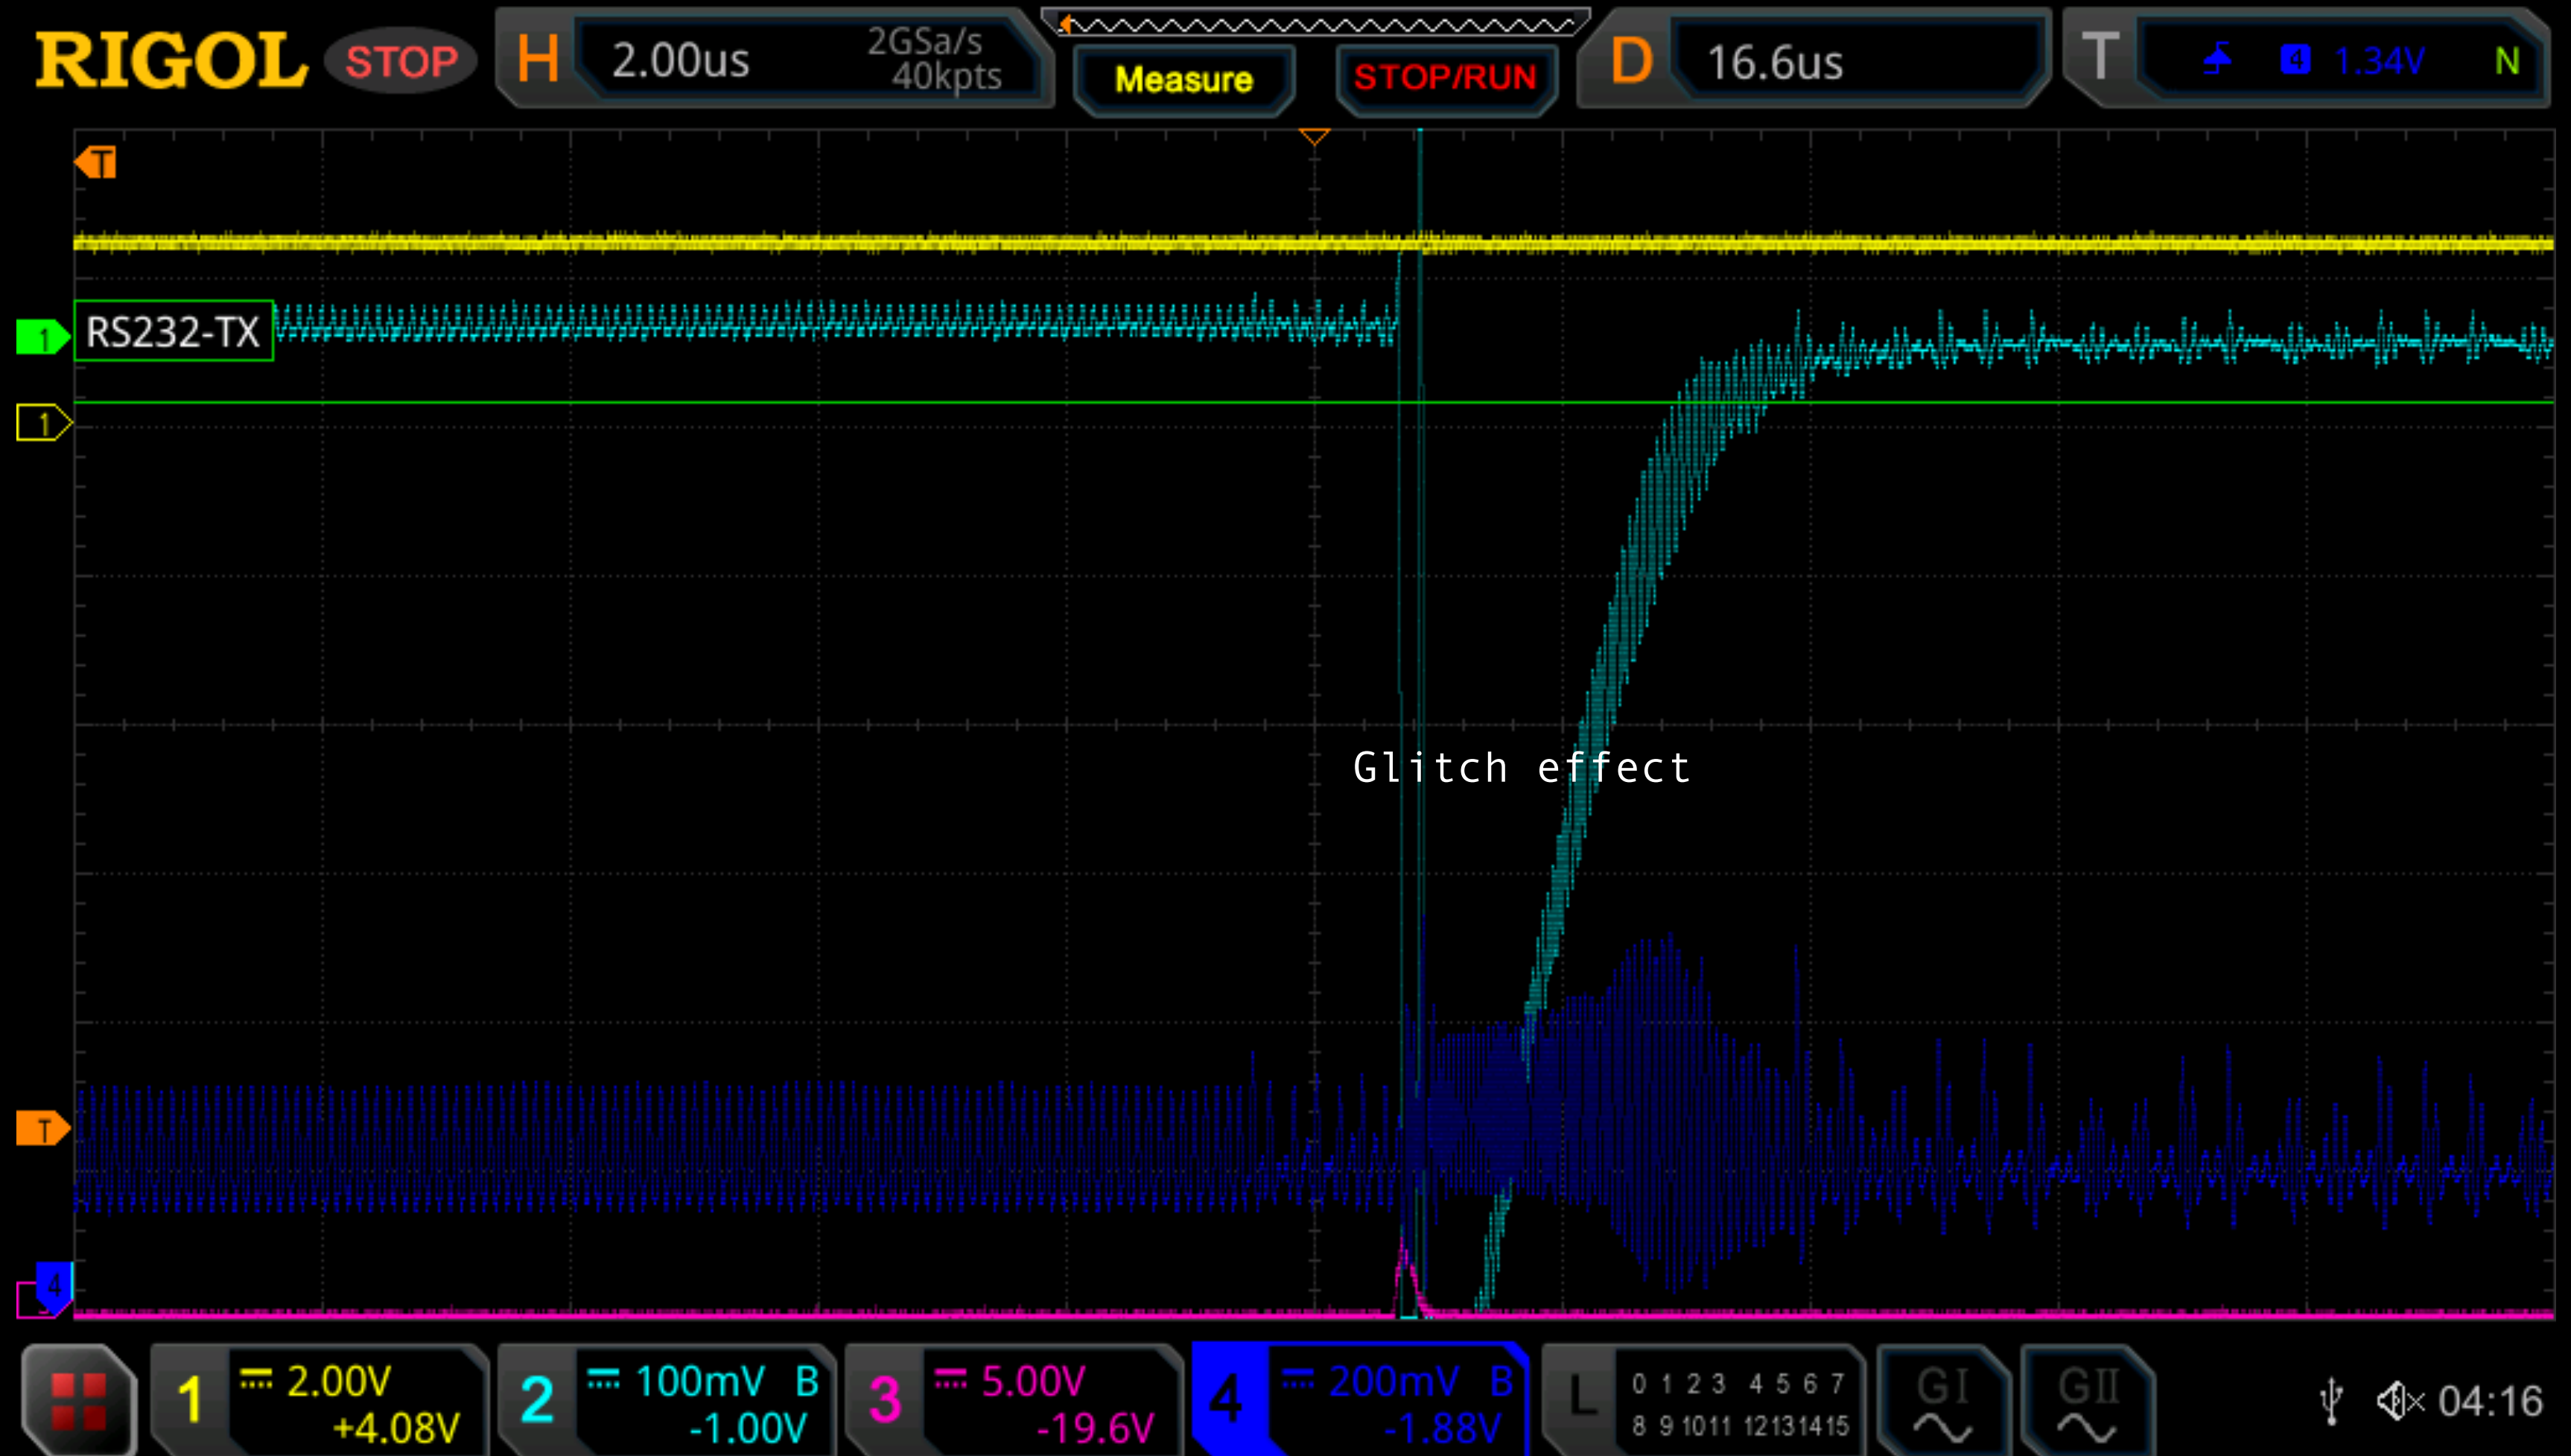
Bypass of APPROTECT on nRF52840

- Successful glitch
- Differences on both Power Lines
- No Flash Activity after

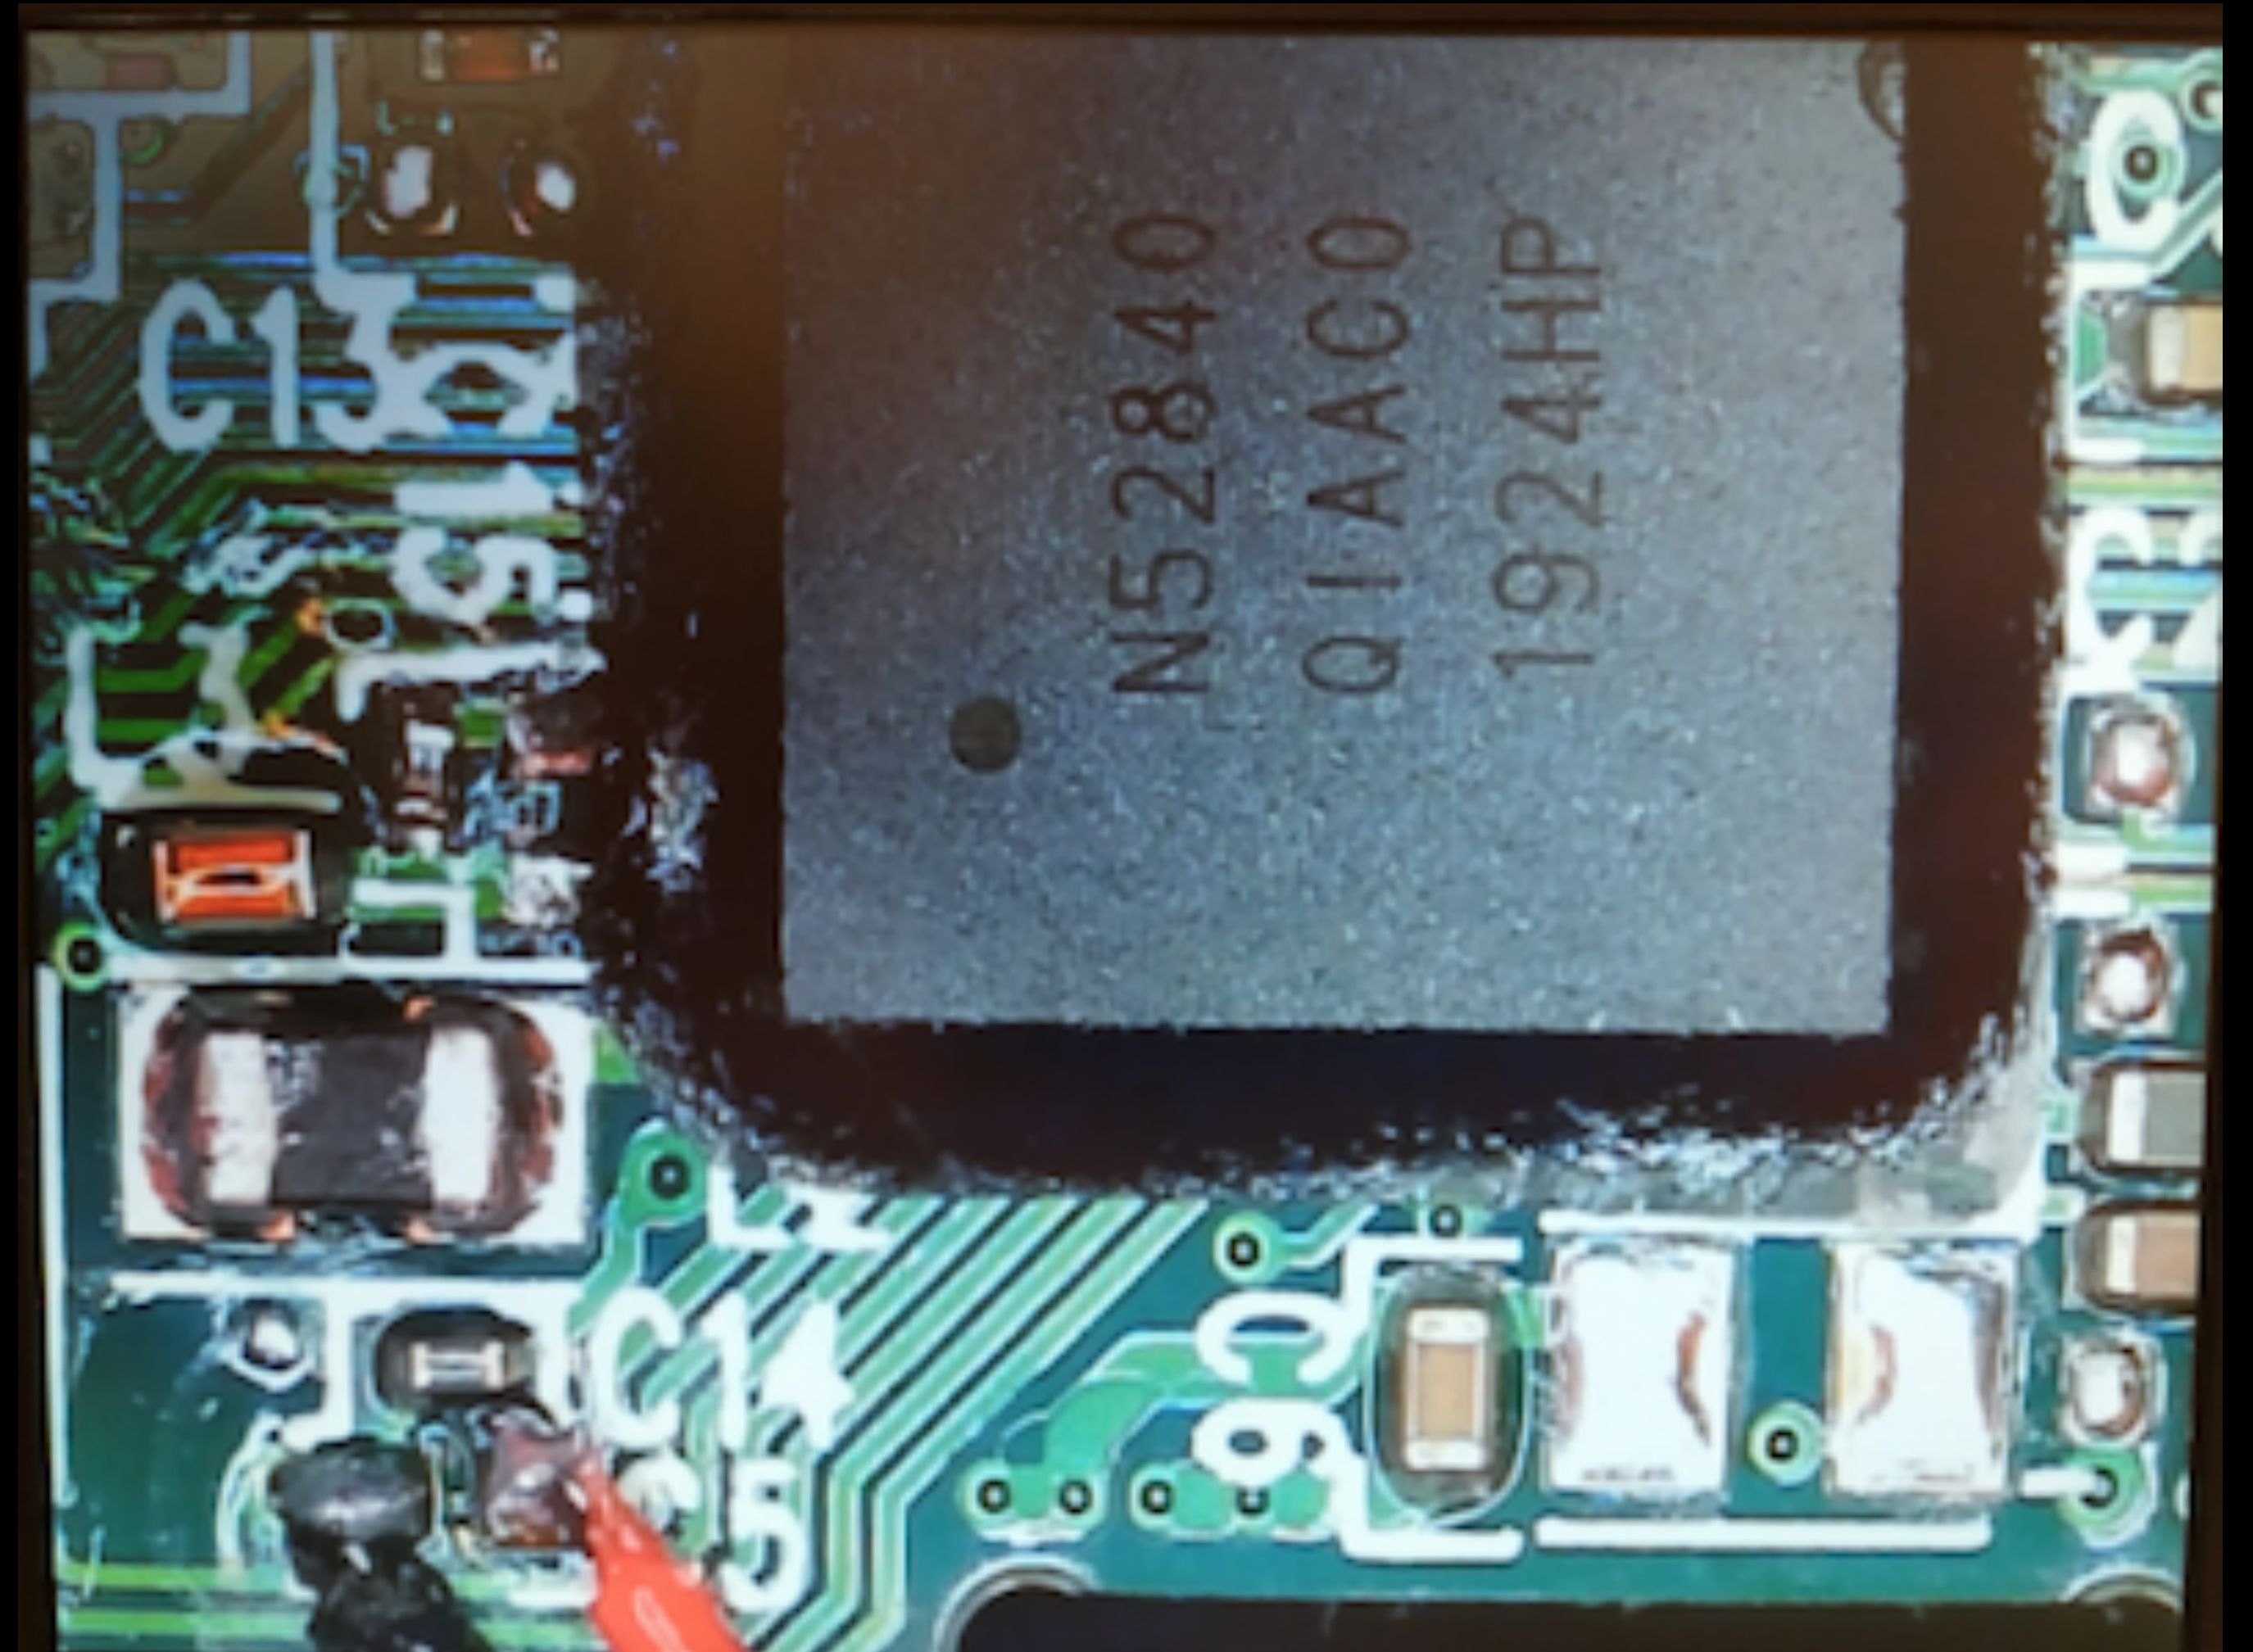
Logitech G Pro

- PCB Reference design
 - provided by Nordic
 - Reused by Logitech
 - Silkscreen
- No need to reverse PCB
 - Easy job

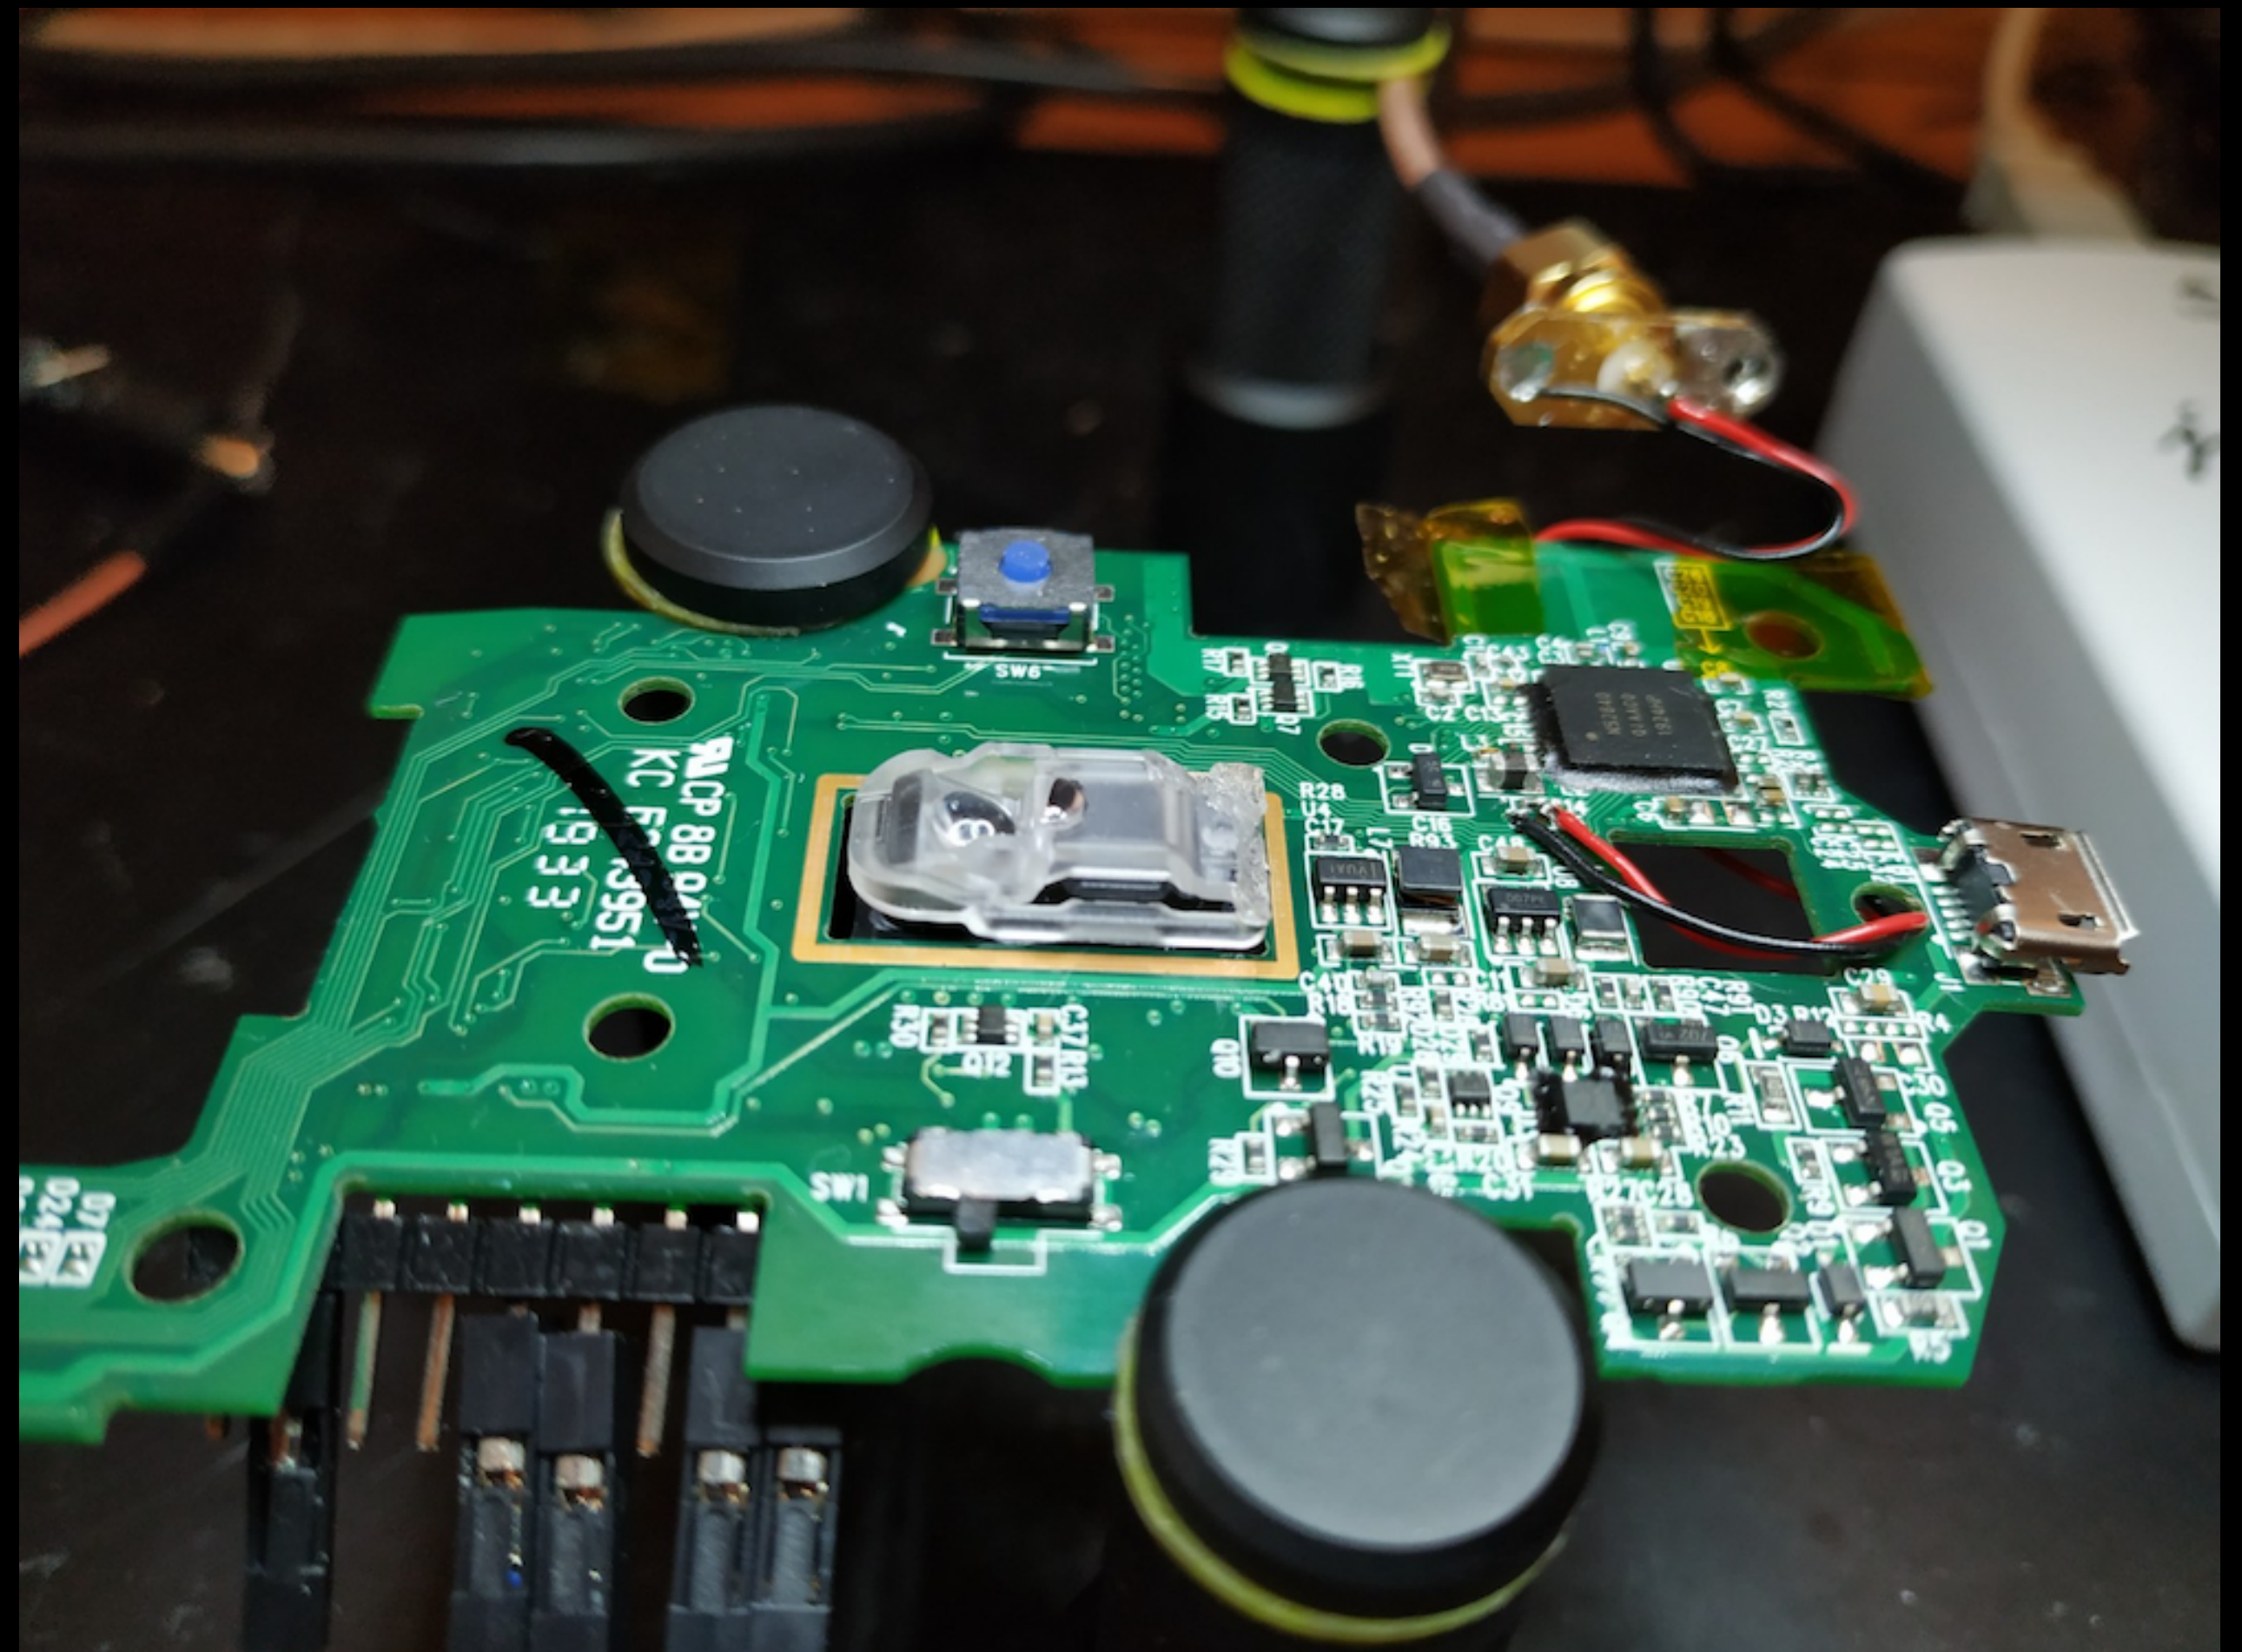
Final Setup

- DEC1 is connected to the glitcher
 - Successful glitch attack using the known parameters
- Firmware is Dumped
- UICR is rewritten to add Debug Persistence to the Device
- Reset

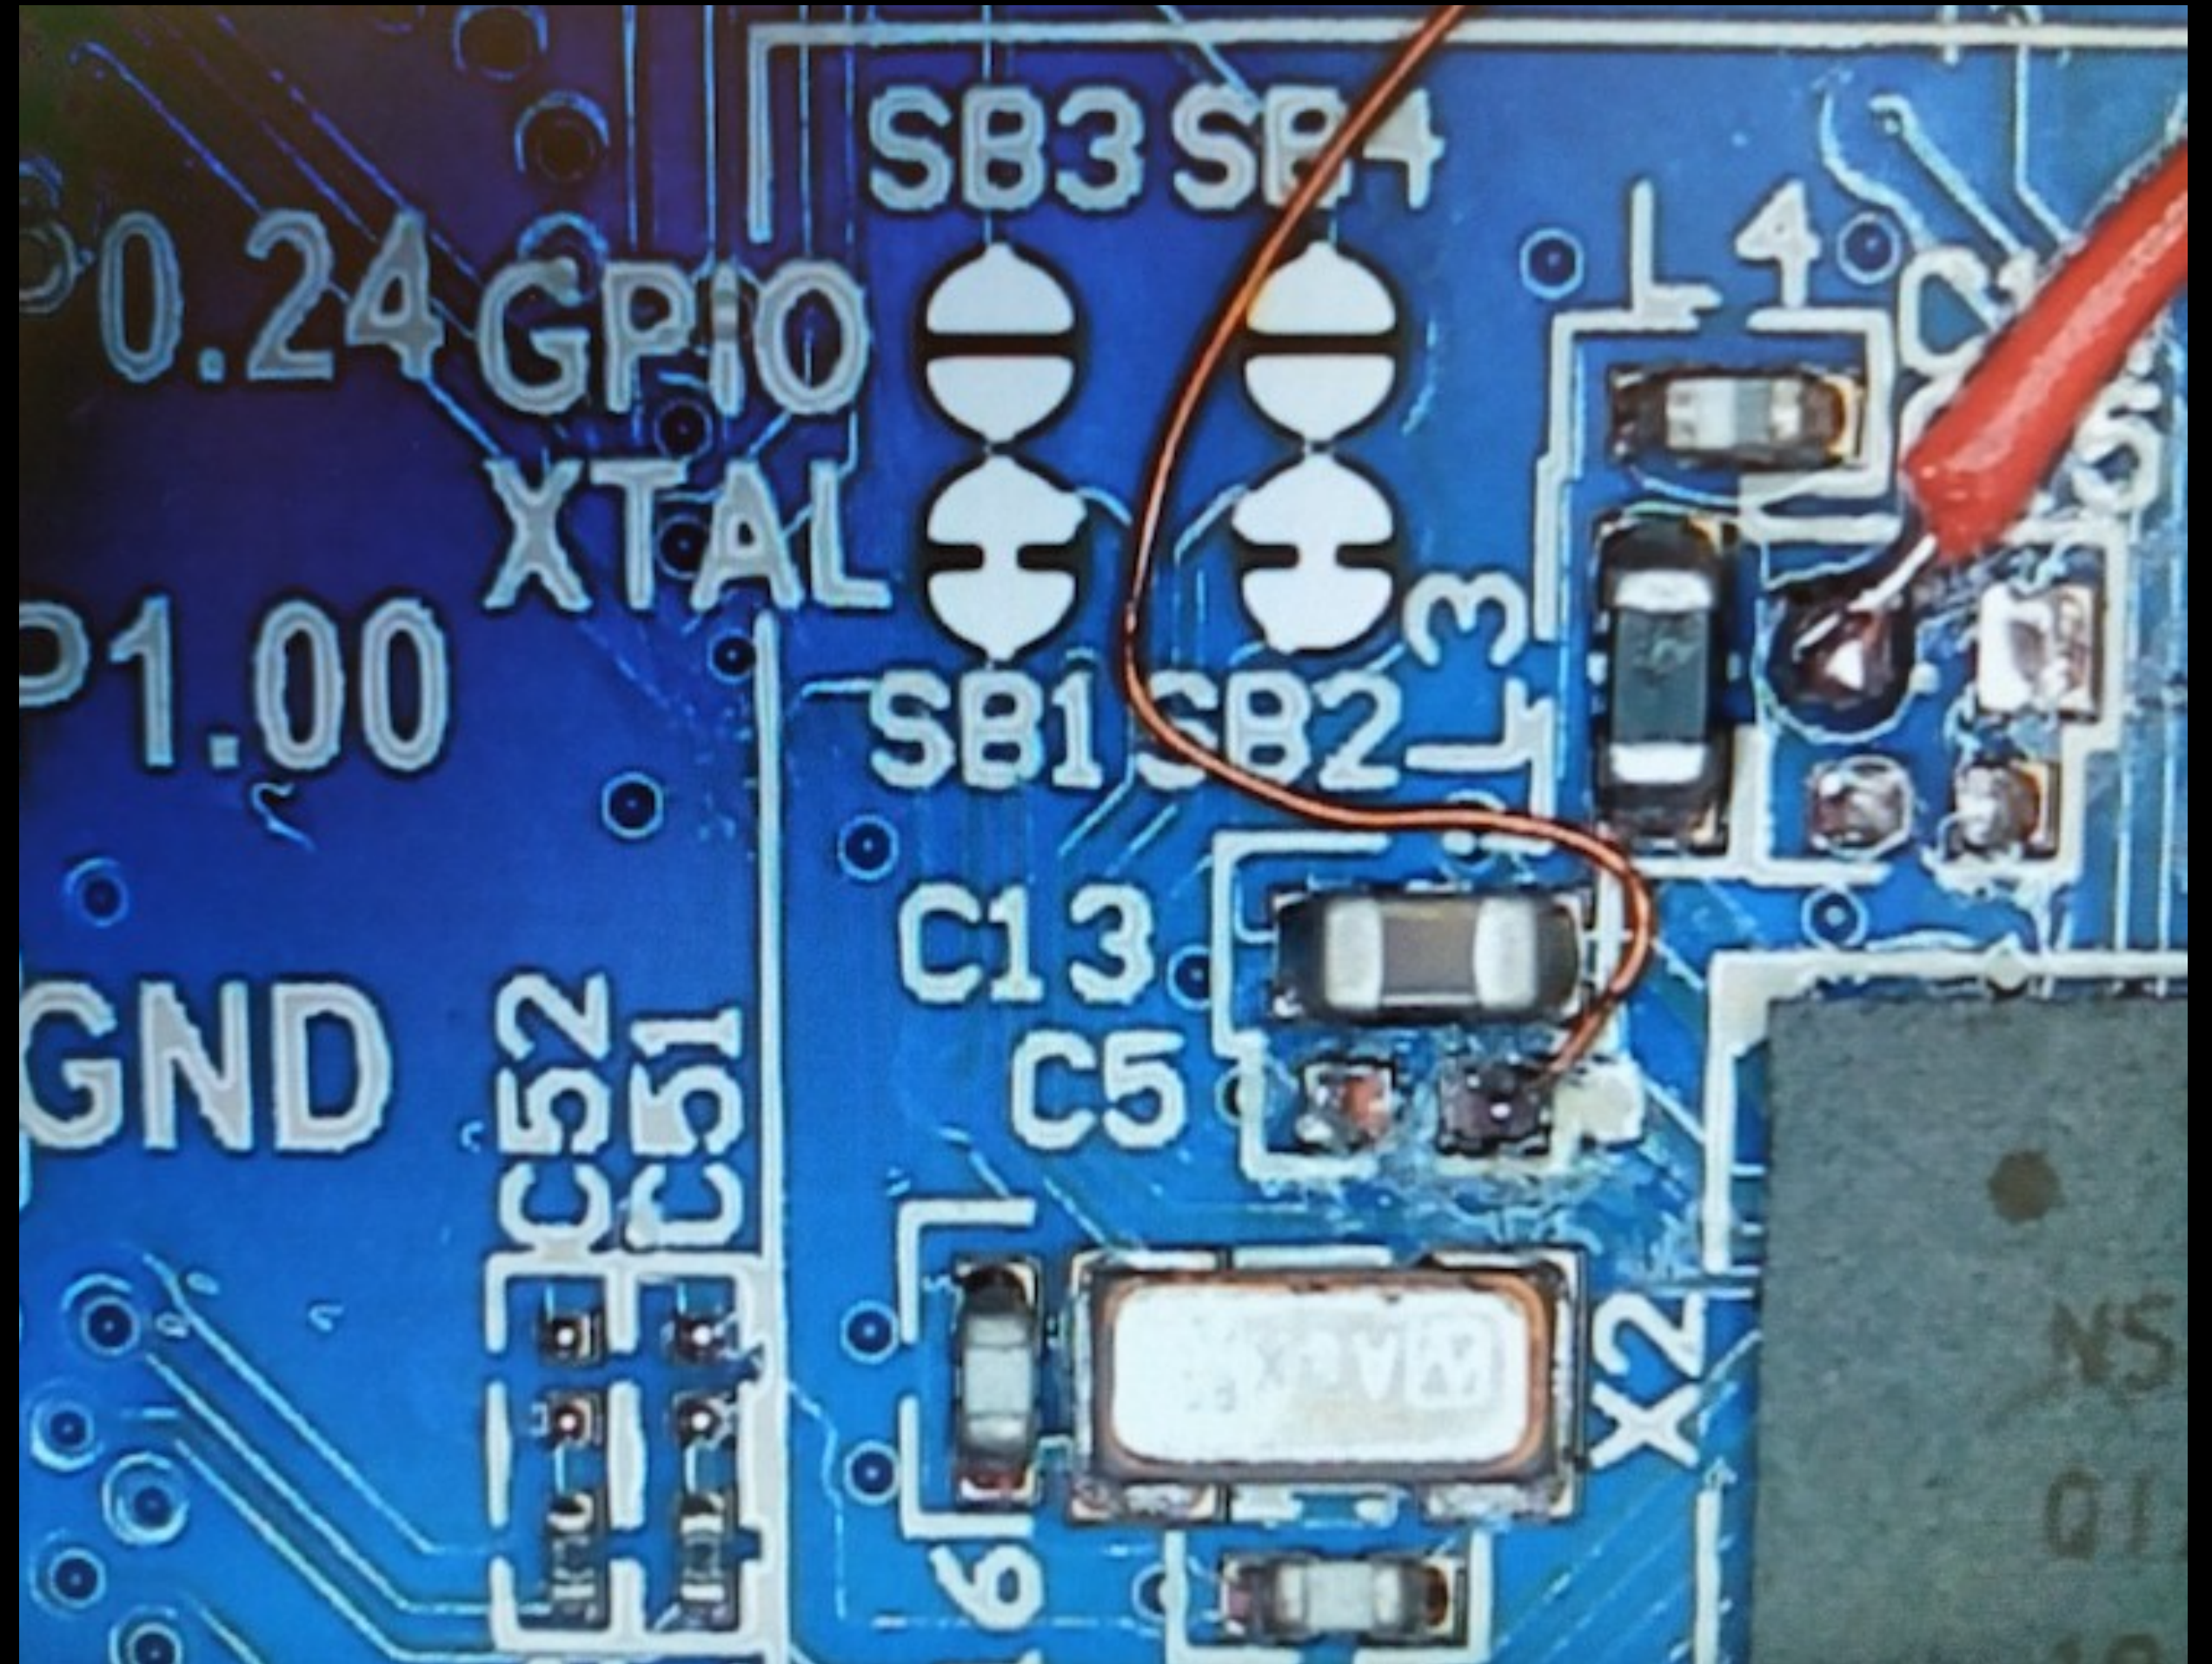
nRF52833

- Enamled wire = DEC1 (CPU_VCC)
- Red wire = DEC4 useful to monitor the chip activity
 - Not necessary
- Don't forget to put GND somewhere...
