Debug Resurrection on nRF52 Series

BlackHat Europe 2020

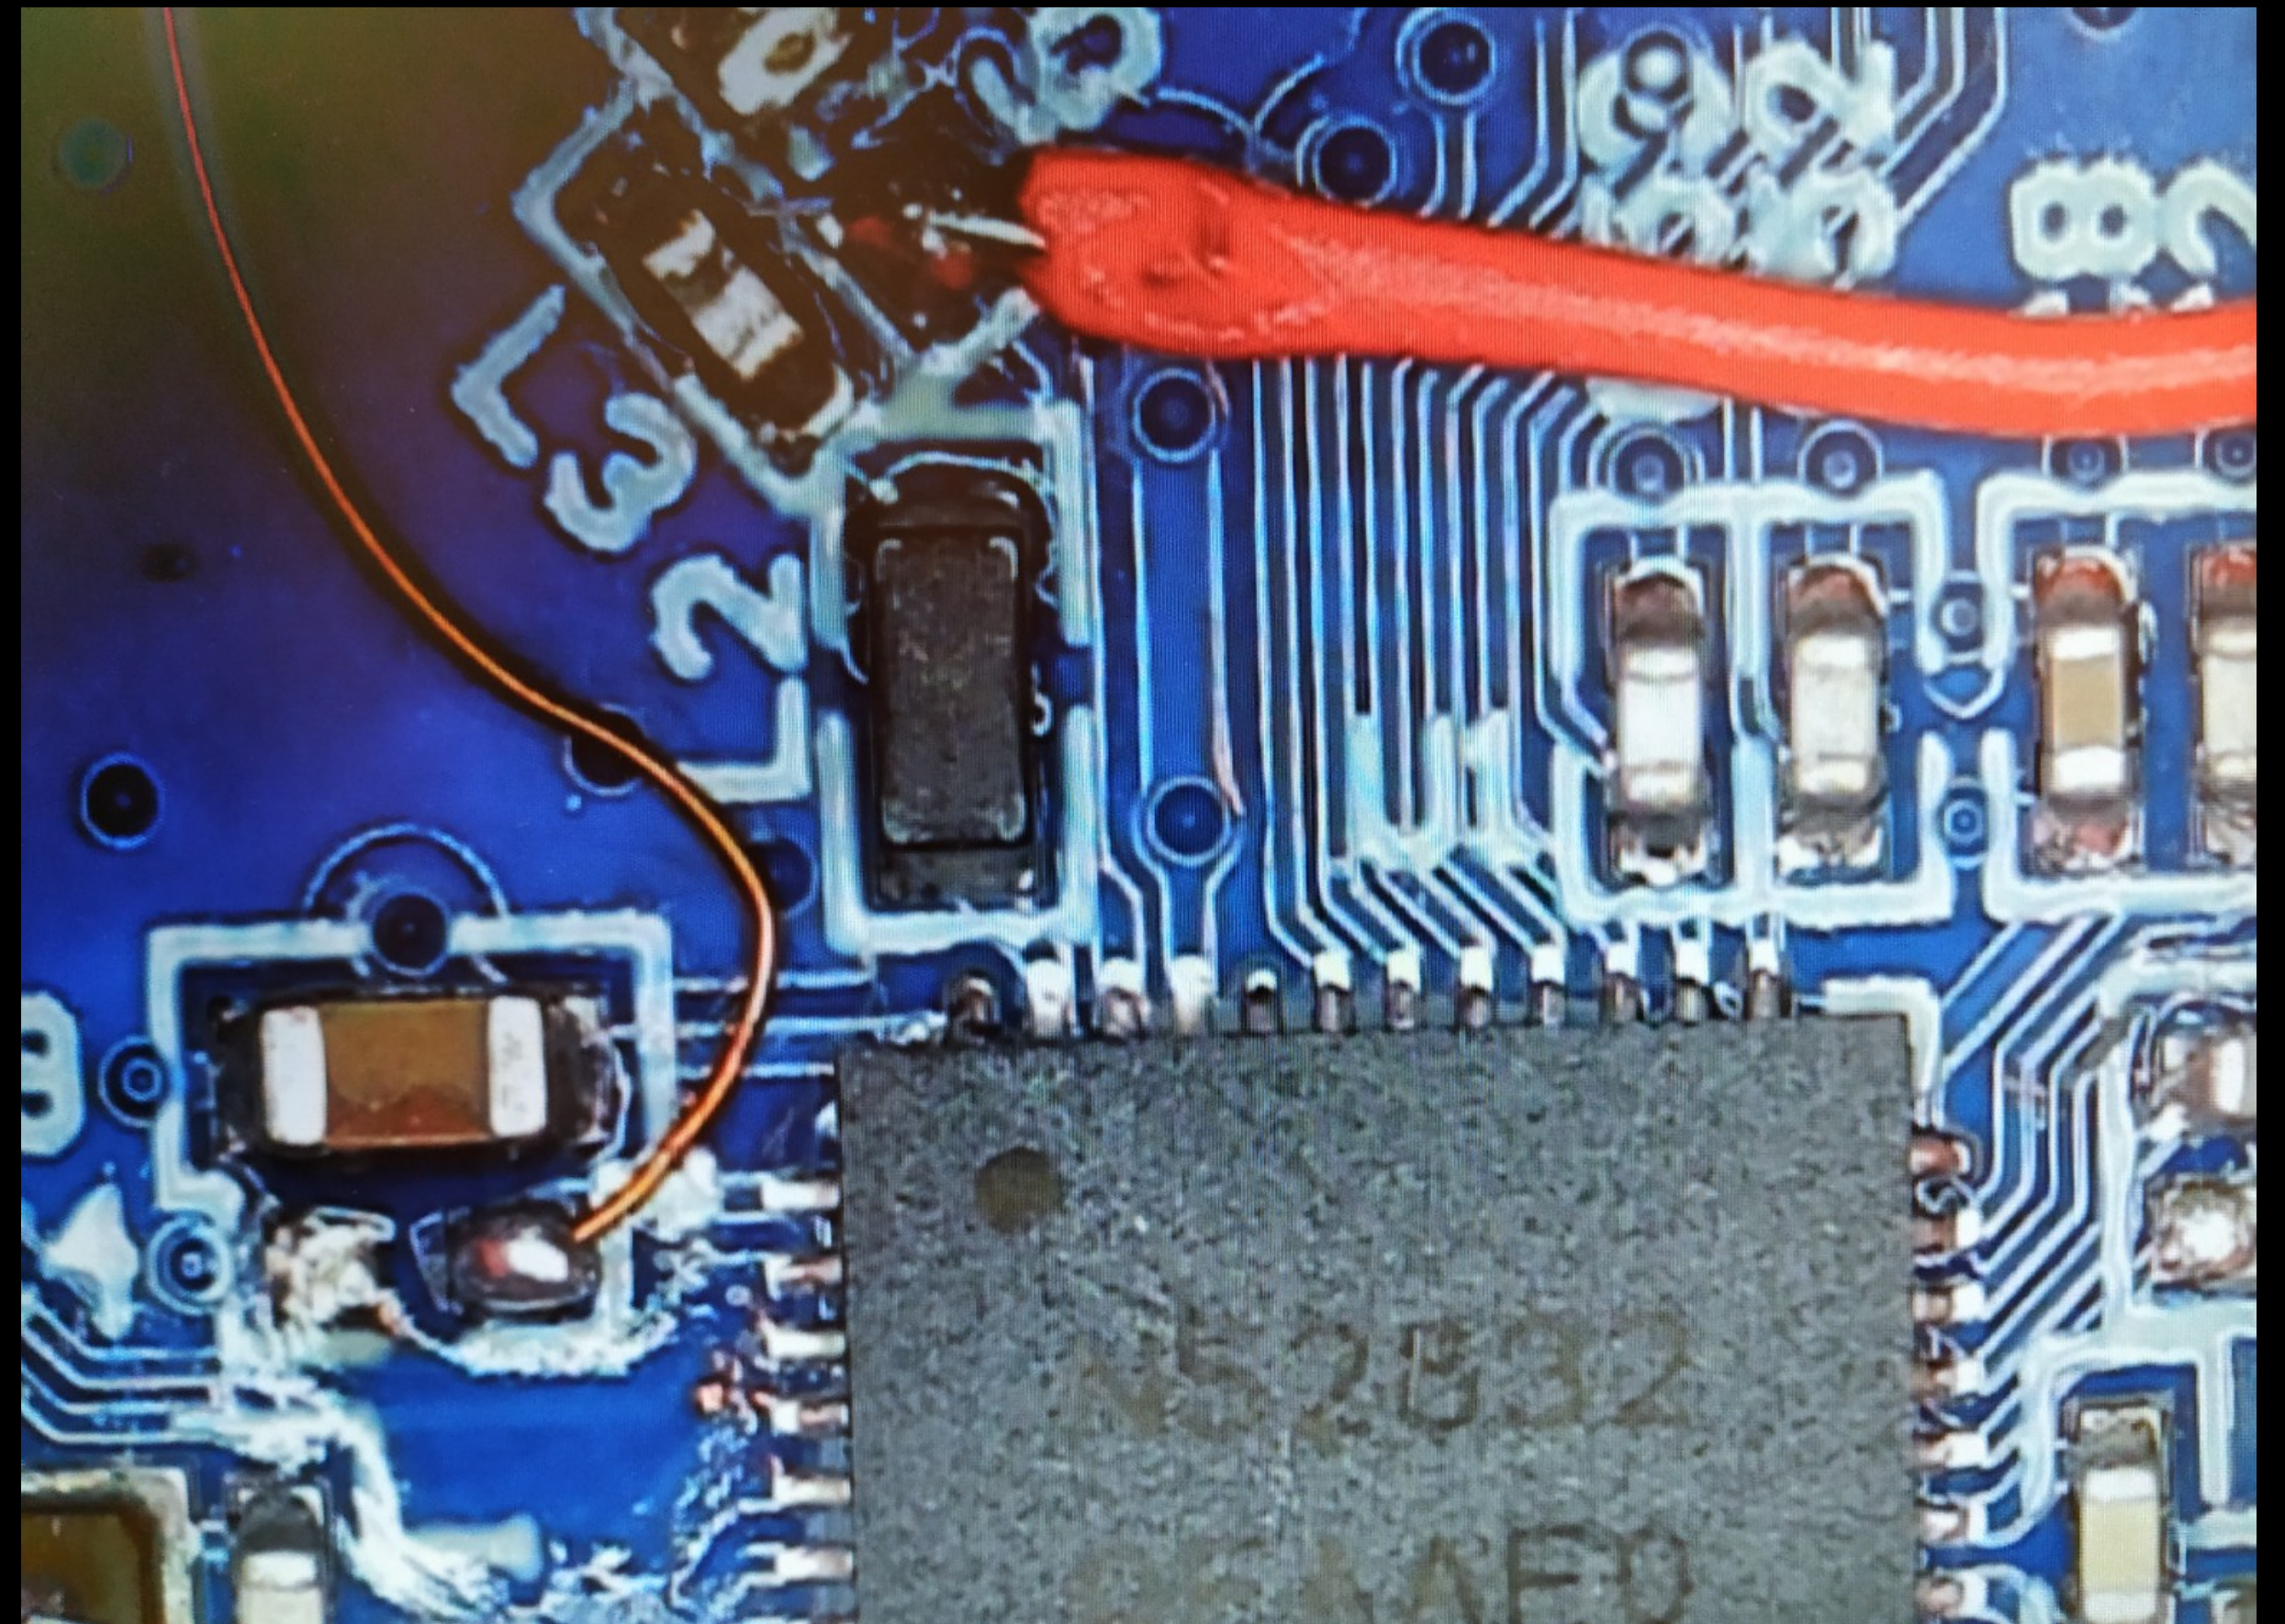
nRF52832

- Enamelled wire = DEC1 (CPU_VCC)
- Red wire = DEC4 useful to monitor the chip activity
 - Not necessary
- Don't forget to put GND somewhere...

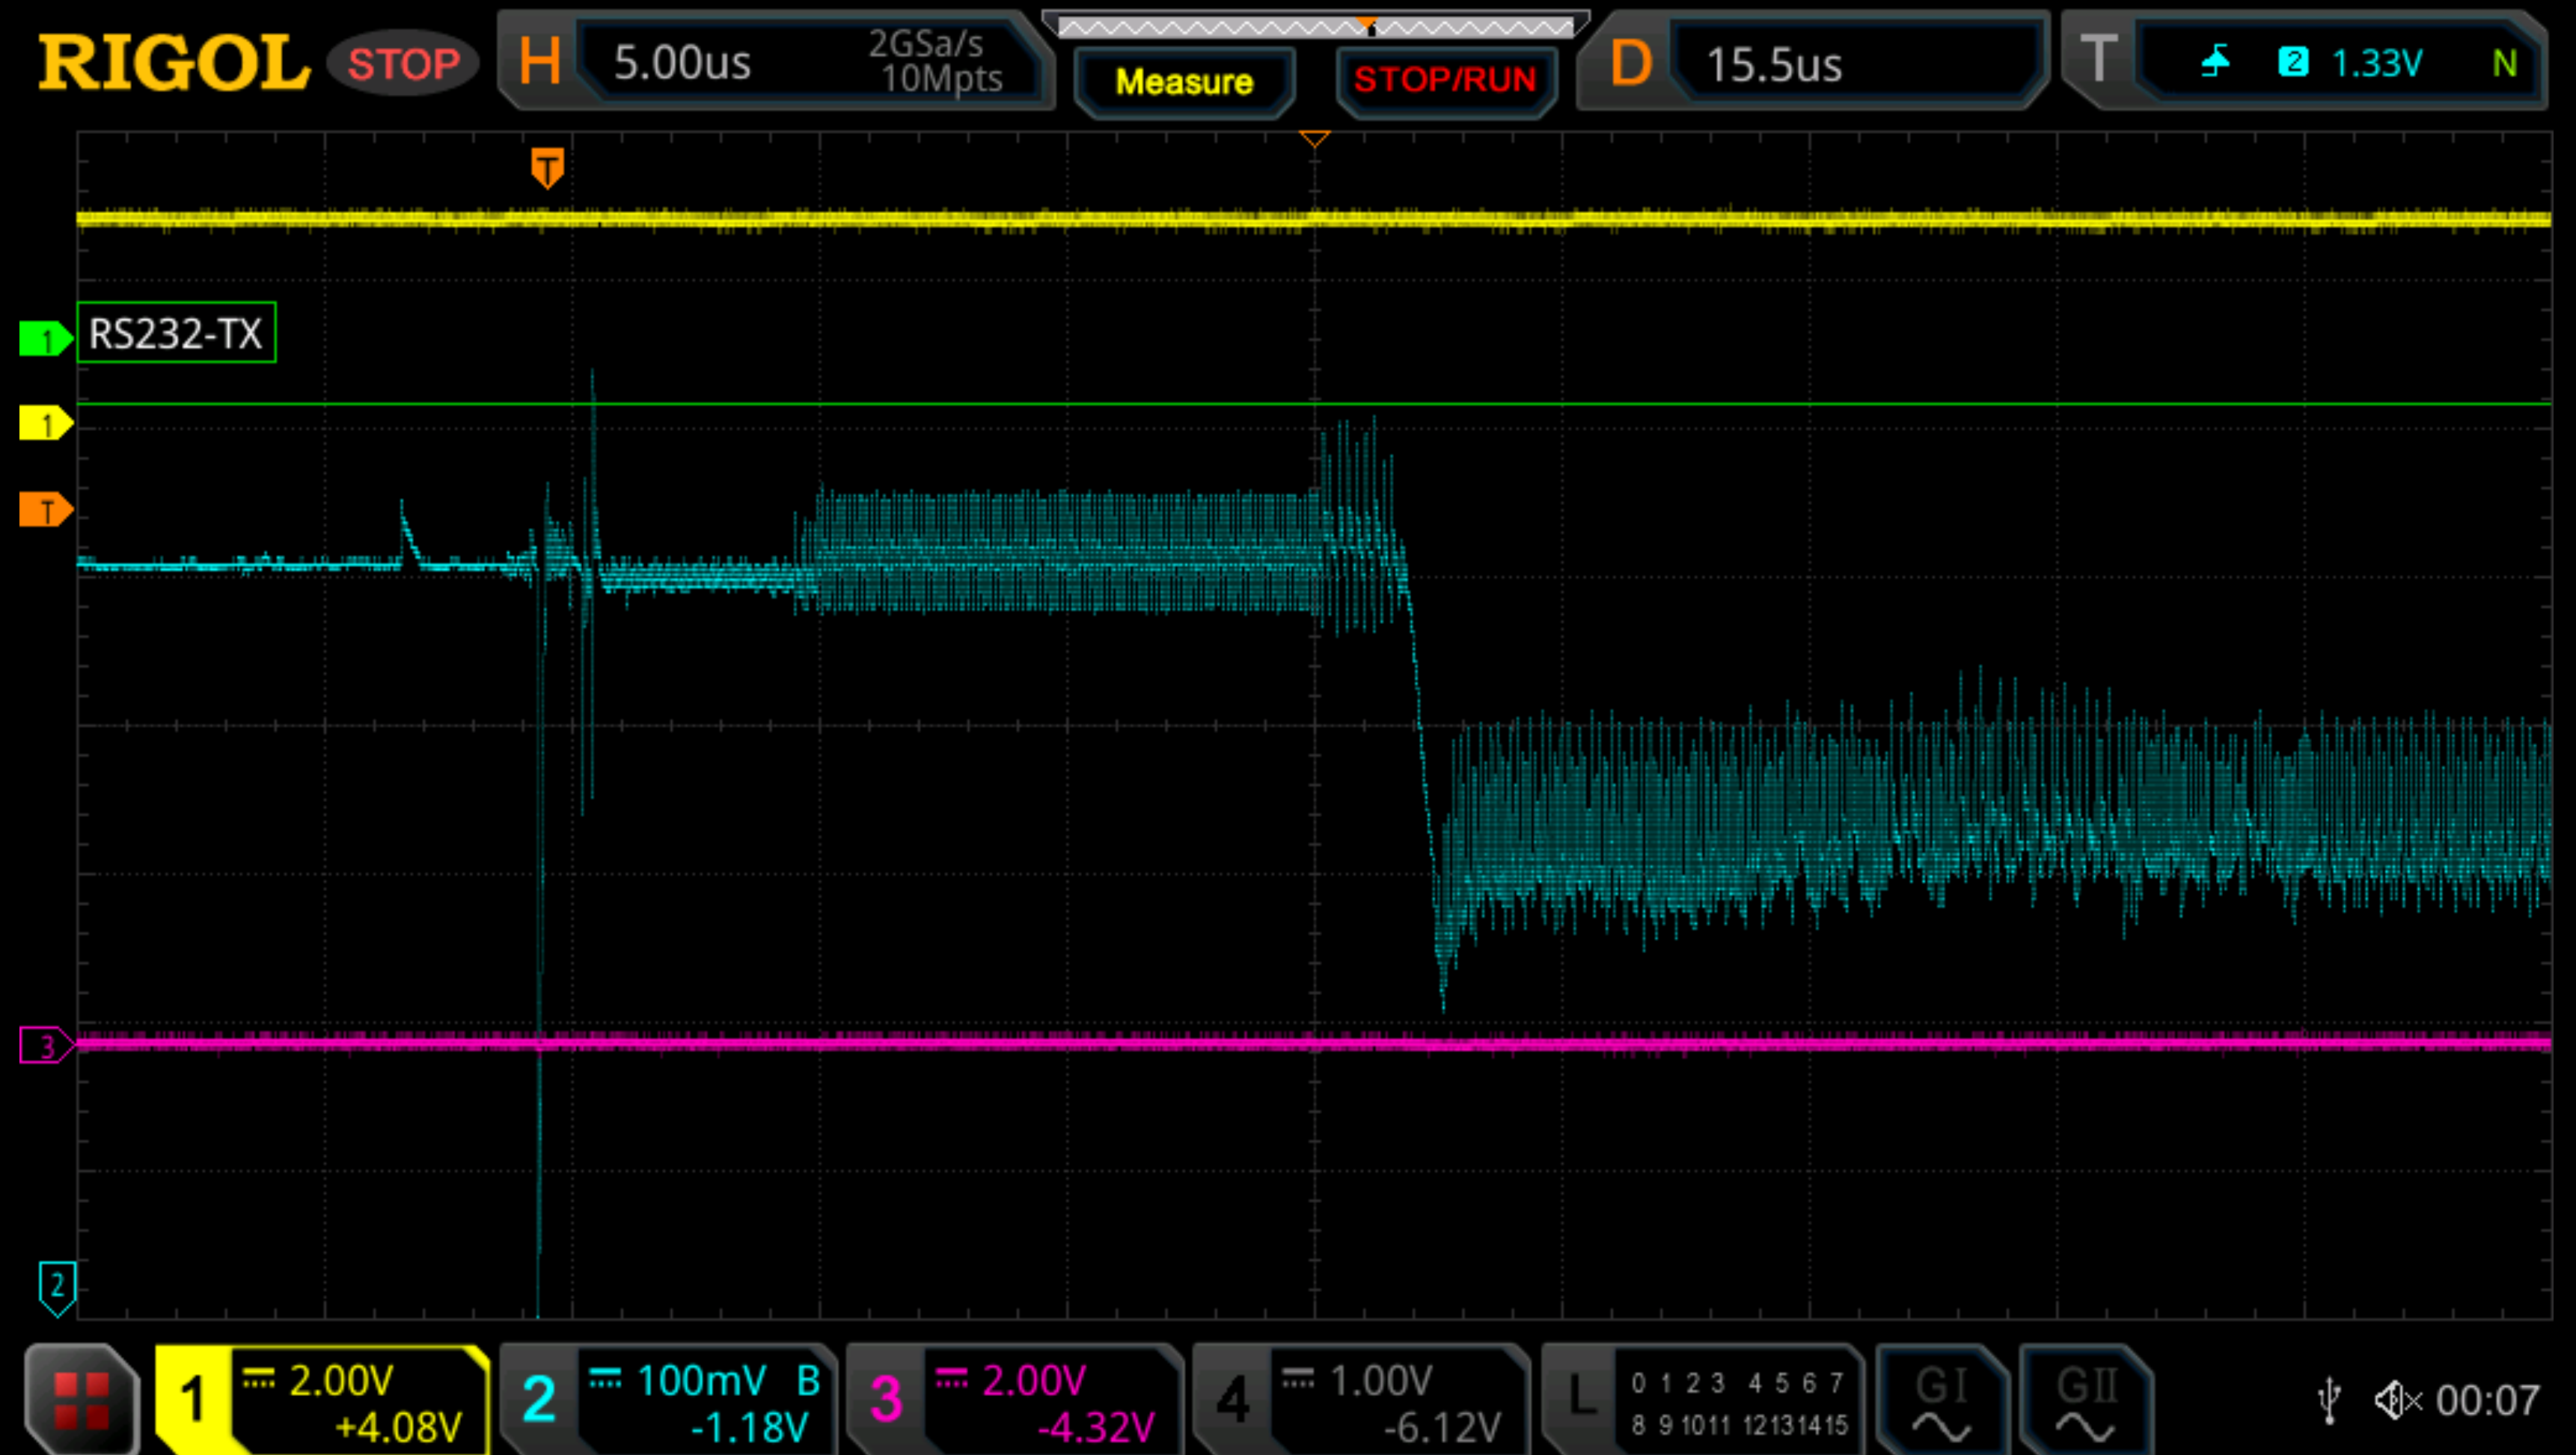
nRF52832

- Clean Power Consumption on DEC1 (CPU)
- The same pattern can be easily identified
